## RESIDENTIAL REHABILITATION / CASE STUDY

# Flexible security during residential rehabilitation

Visible, adaptable surveillance for an occupied residential property during onsite improvements.

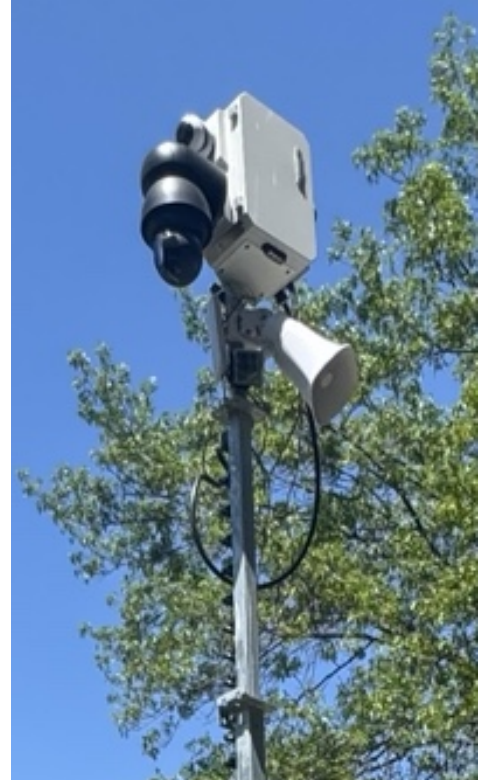
Actual project photo: close crop of the tower-mounted camera assembly. Property context has been excluded.

Three mobile solar-powered towers were initially deployed. The tower count was later reduced as site requirements changed. Coverage remained in place during parcel-locker construction.

Remote live and recorded video access, AI-assisted detection, and audible/visual deterrence. The mobile system required no permanent site power or internet connection.

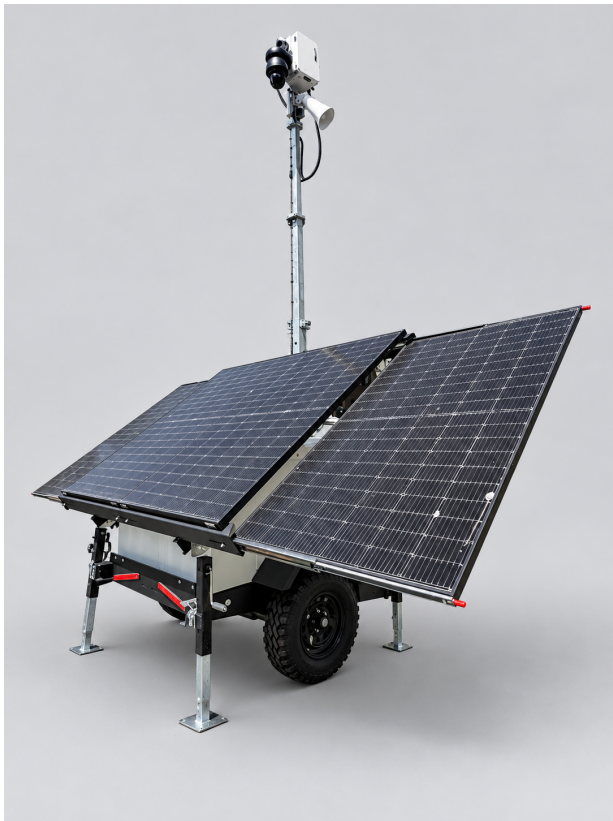
Project photo with background removed for privacy. Full tower shown; background digitally edited.

Relocatable equipment, solar-powered deployment, detection alerts, and live or recorded video access supported changing needs during rehabilitation and onsite improvements.
